Park View HOA

CAPITAL RESERVE STUDY

Report Number: 20-13

Site Inspection Date: November 28th, 2020

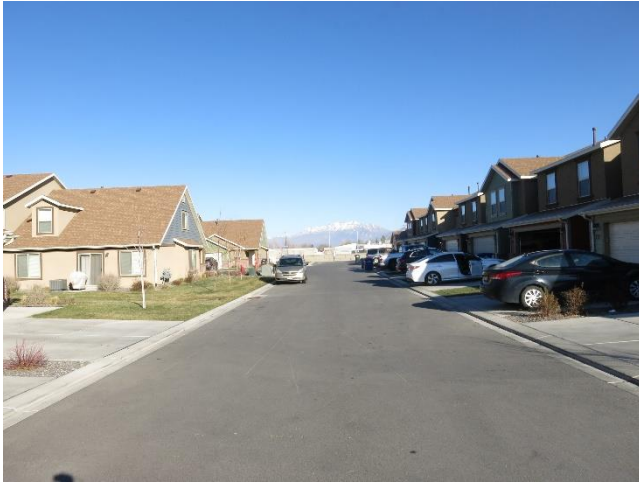
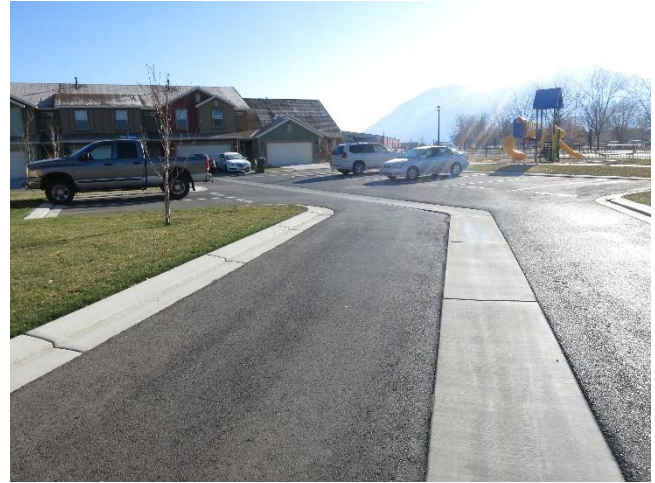
Component Name: 2" Asphalt Mill & Overlay
 Component Number: Drive Materials 1001

Component Life Expectancy: 20 years
 Average Age of Component: 5 years
 Remaining Component Life: 15 years

The AASHTO Pavement Design Guide recommends asphalt paving receive immediate rehabilitation when signs of alligator cracking or longitudinal cracks wider than 1/4 inch are present. An asphalt overlay is recommended every 15 to 20 years. The overlay will add new structure to the road and fix any pot holes or structural defects that may develop over time. Without an overlay, the road base beneath the paving could deteriorate leading to a complete asphalt replacement.

Areas that show signs of sinking can often be attributed to base course failure. These areas should be repaired prior to a new overlay.

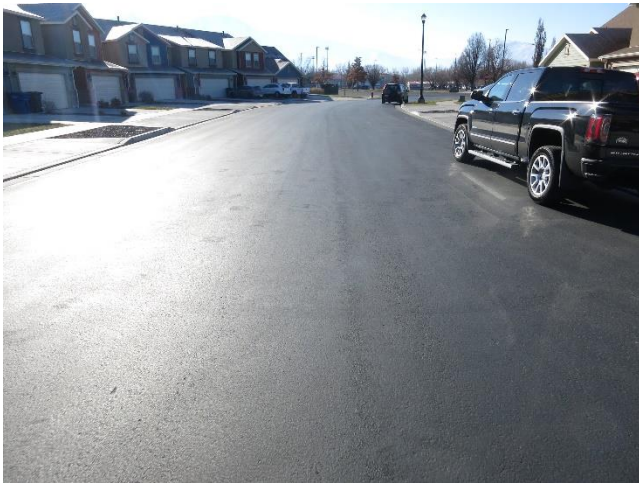
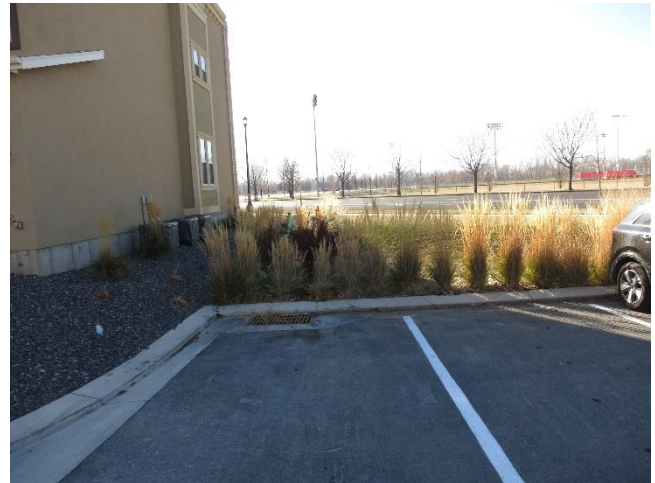
Component Name: Asphalt Slurry Seal
 Component Number: Drive Materials 1002

Component Life Expectancy: 5 years
 Average Age of Component: 3 years
 Remaining Component Life: 2 years

A crack and slurry seal is recommended every 5 years. Slurry seal will help protect the asphalt from degradation by sealing cracks, preventing water seepage and damage. It also rejuvenates the surface and renews the oils, keeping the asphalt from becoming overly brittle.

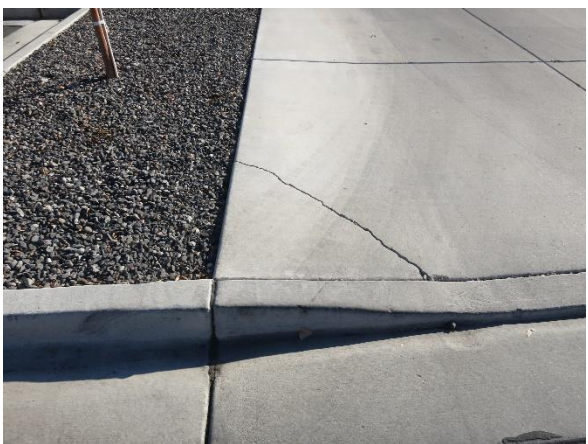
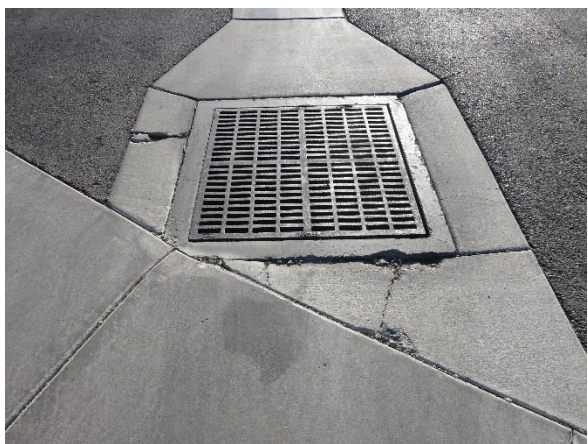
Component Name: Concrete Repair/Replace
Component Number: Drive Materials 1003

Reoccurring Allowance: 5 years
Beginning Year 2025

The American Public Works Association (Utah Chapter) recommends concrete panels to be repaired and or replaced when there are 3 or more cracks that extend the full depth of the slab or if there is spalling that covers more than 25% of the panel. Protruding edges should be ground down to prevent further damage and to prevent any safety hazards.

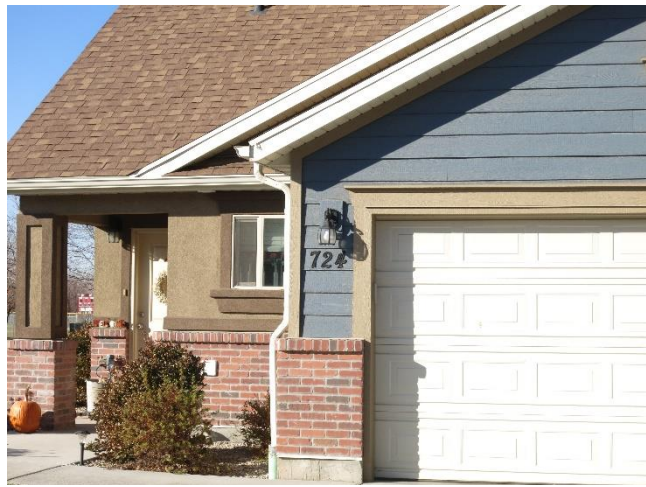
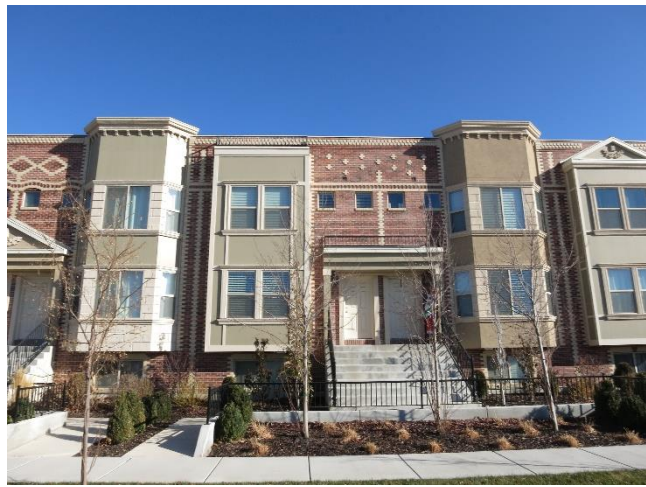
Component Name: Brick / Stone
Component Number: Building Exterior 2001

Brick, stone, and concrete are durable building materials that can last a very long time. Because of the long lifespan of this component, it is plausible that it will last the lifetime of the building. Therefore, no money has been allocated to replace or maintain this item.

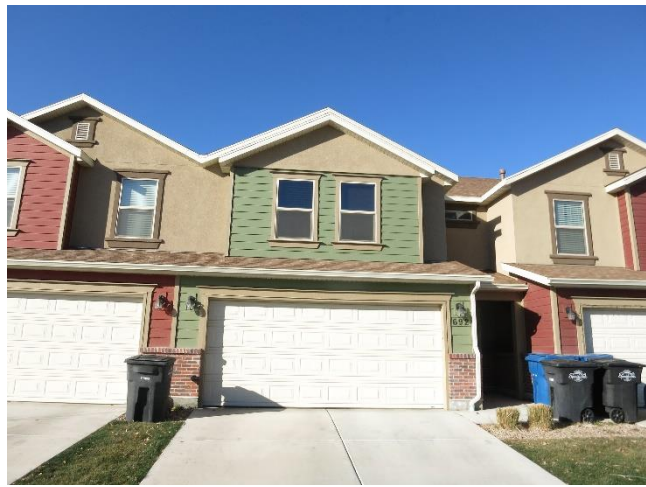
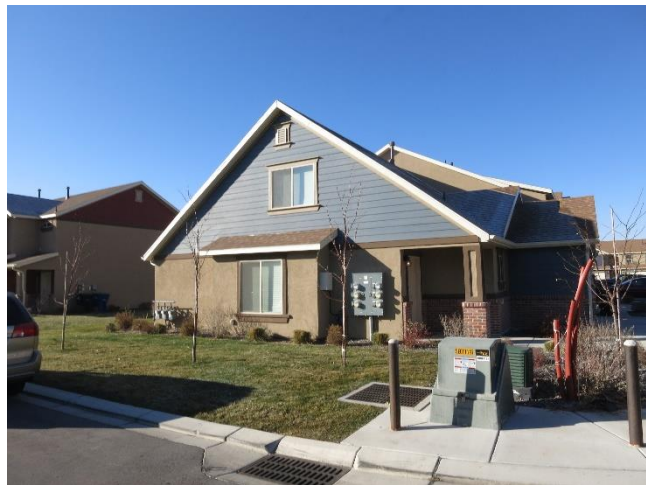
Component Name: Exterior Paint
Component Number: Building Exterior 2002

Component Life Expectancy: 12 years
Average Age of Component: 5 years
Remaining Component Life: 7 years

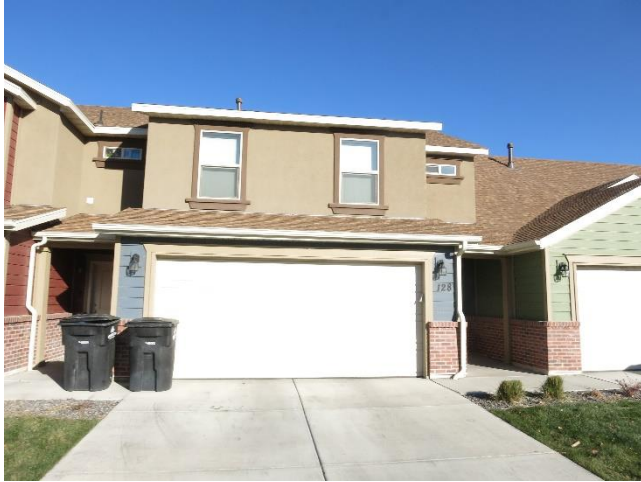
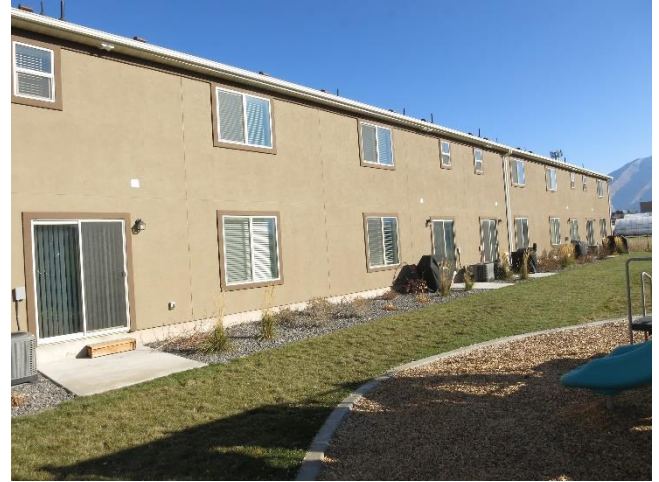
Component Name: Stucco
 Component Number: Building Exterior 2003

Reoccurring Repair Allowance: 5 years
 Beginning Year: 2025

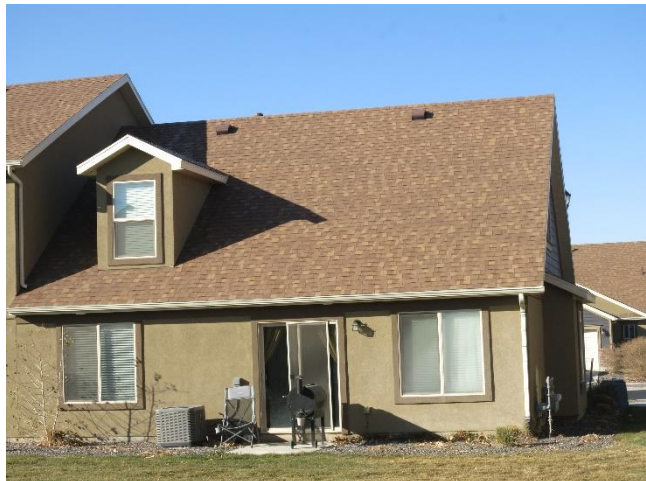
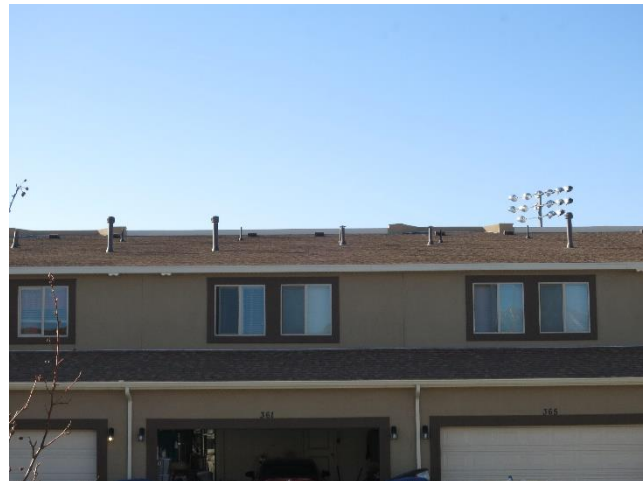
Component Name: Roofing Replacement
 Component Number: Building Exterior 2004

Component Life Expectancy: 30 years
 Average Age of Component: 5 years
 Remaining Component Life: 25 years

The roofs for each unit were observed to be asphalt shingle roofing.

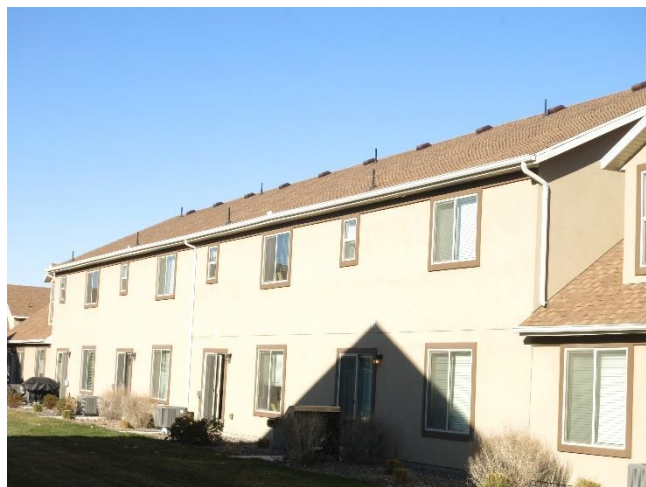
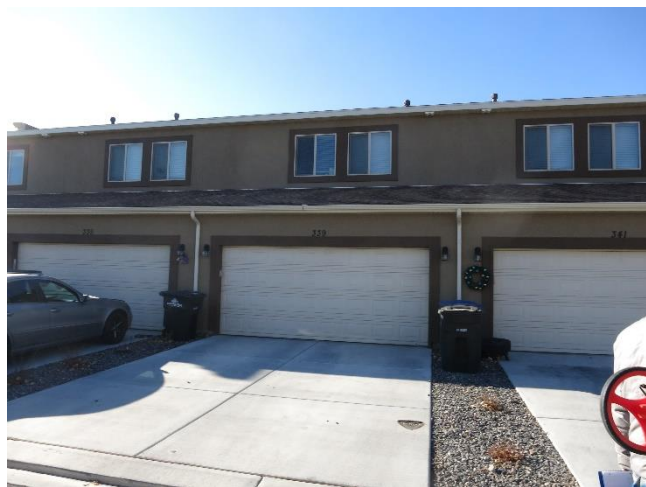
Component Name: Gutter & Downspouts
Component Number: Building Exterior 2005

Component Life Expectancy: 30 years
Average Age of Component: 5 years
Remaining Component Life: 25 years

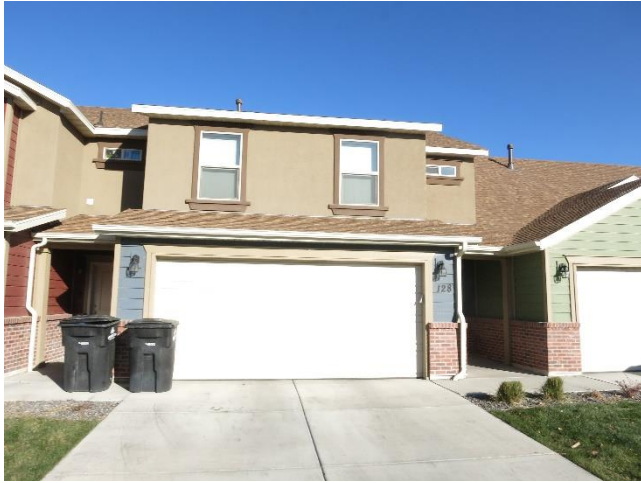
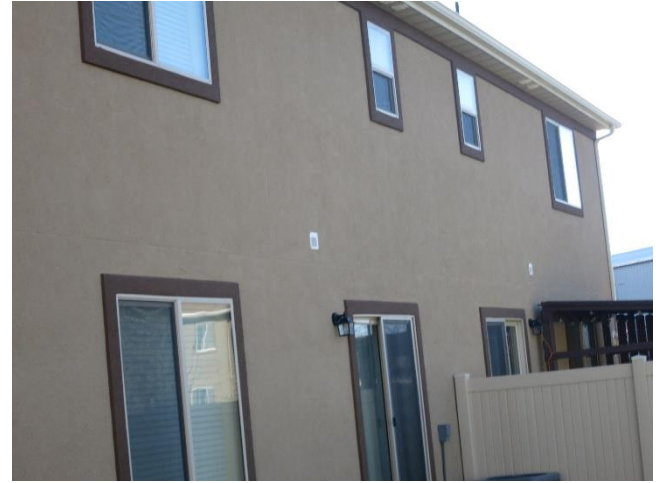
Component Name: Exterior Light Fixtures
 Component Number: Building Exterior 2006

Component Life Expectancy: 20 years
 Average Age of Component: 5 years
 Remaining Component Life: 15 years

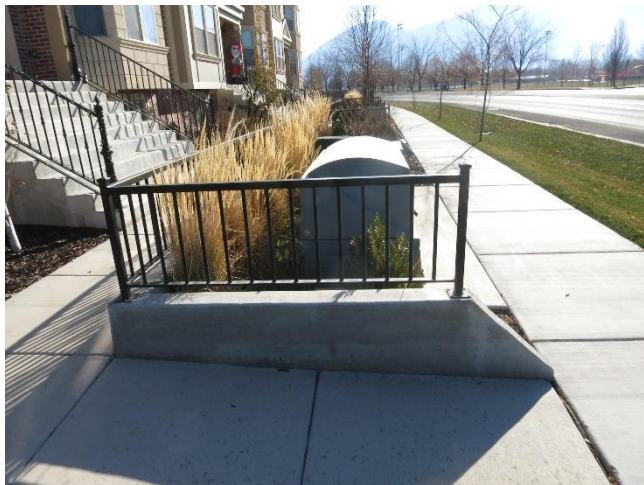
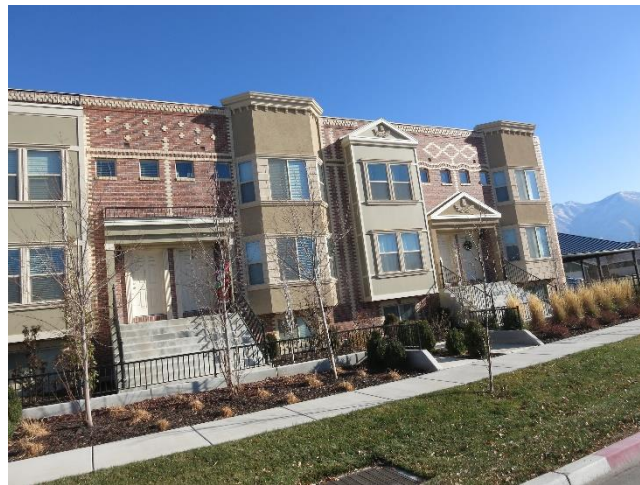
Component Name: Metal Deck Railing Maintenance
 Component Number: Building Exterior 2008

Component Life Expectancy: 15 years
 Average Age of Component: 5 years
 Remaining Component Life: 10 years

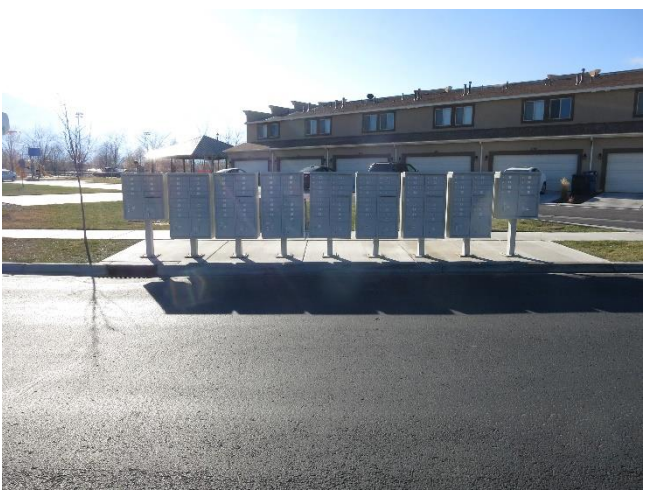
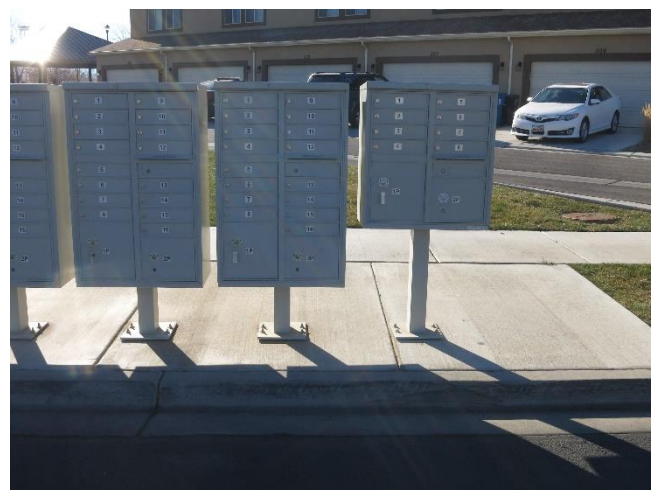
Component Name: Mailboxes
Component Number: Common Development 3001

Component Life Expectancy: 20 years
Age of Component: 5 years
Remaining Component Life: 15 years

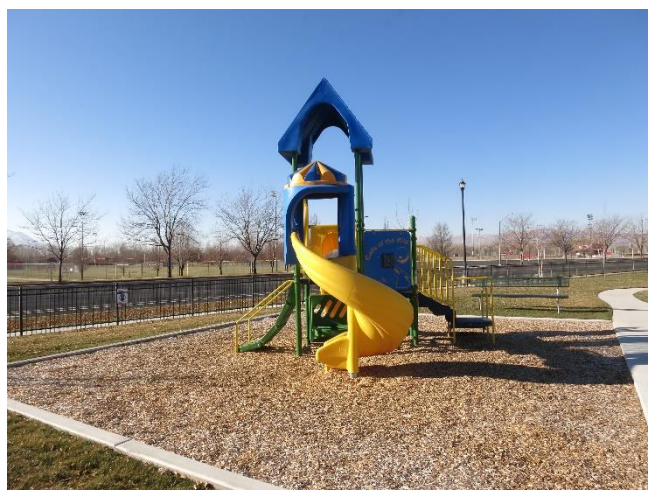
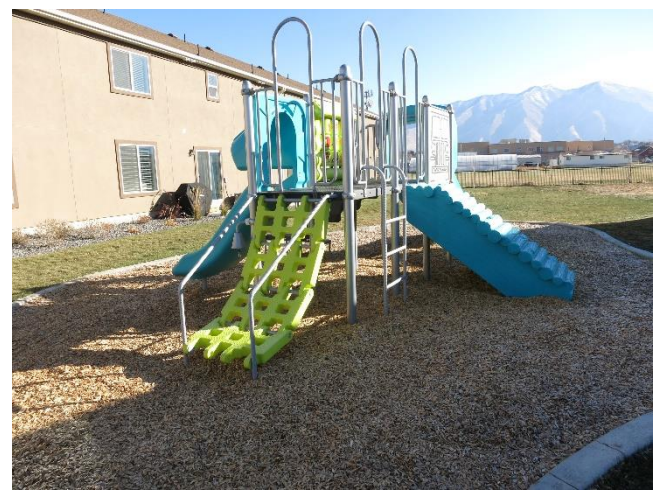
Component Name: Playground Equipment
Component Number: Common Development 3005

Component Life Expectancy: 15 years
Average Age of Component: 5 years
Remaining Component Life: 10 years

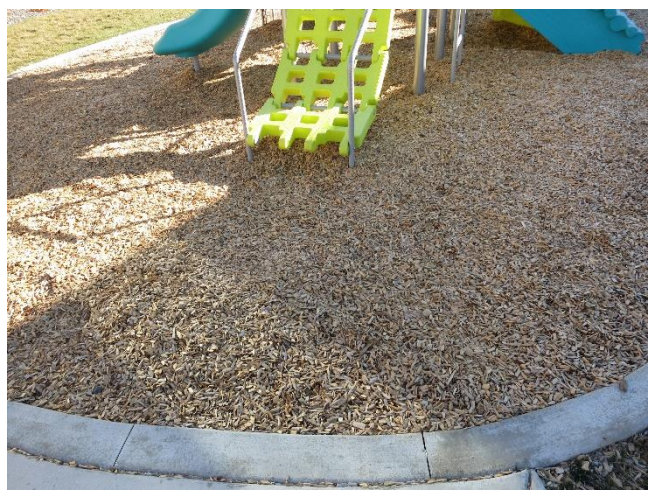
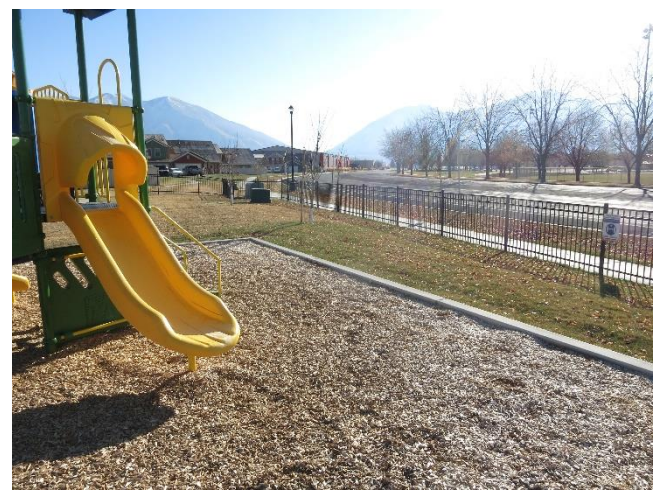
Component Name: Playground Ground Cover
Component Number: Common Development 3006

Component Life Expectancy: 3 years
Average Age of Component: 2 years
Remaining Component Life: 1 years
