Park View HOA

CAPITAL RESERVE STUDY

Report Number: 20-13

Site Inspection Date: November 28th, 2020

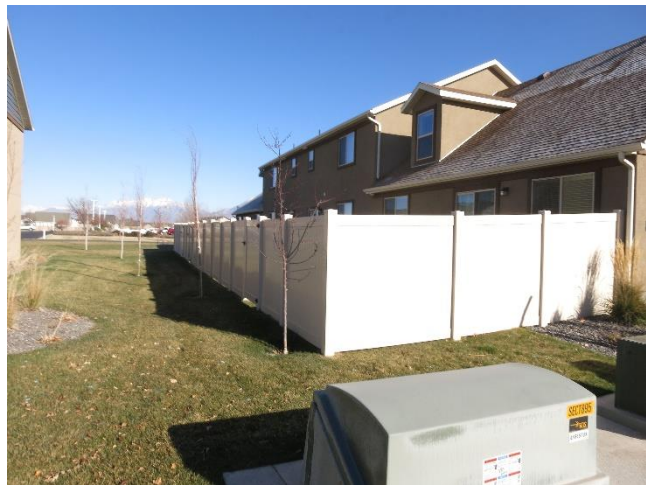
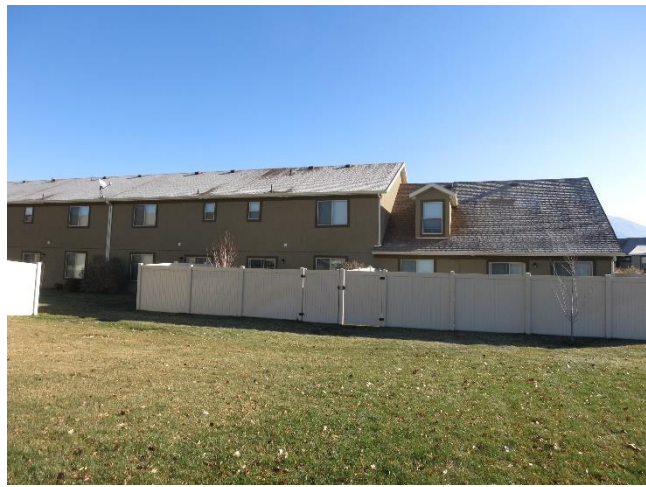
Component Name: Vinyl Fencing
Component Number: Building Exterior 2007

Component Life Expectancy: N/A years
Average Age of Component: years
Remaining Component Life: years

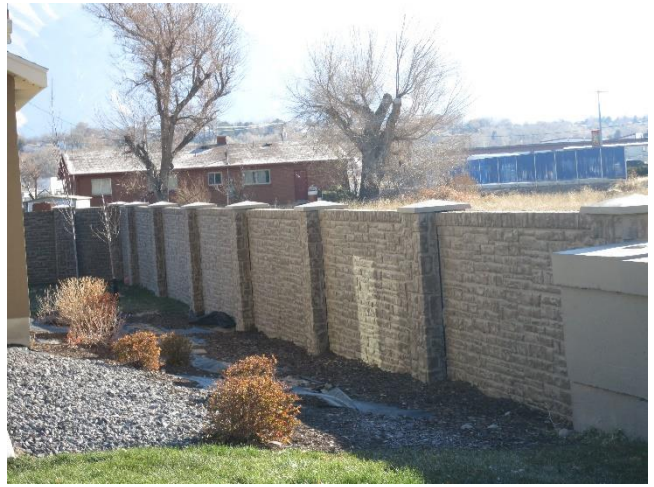
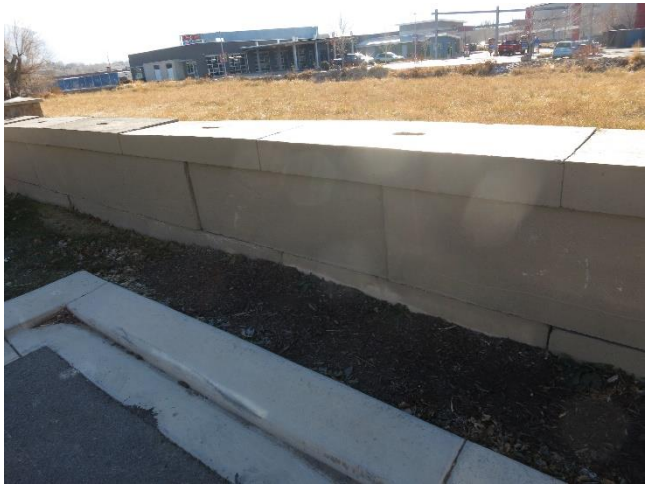
Component Name: Concrete Panel Fencing
Component Number: Common Development 3002

Component Life Expectancy: ∞ years
Average Age of Component: years
Remaining Component Life: years

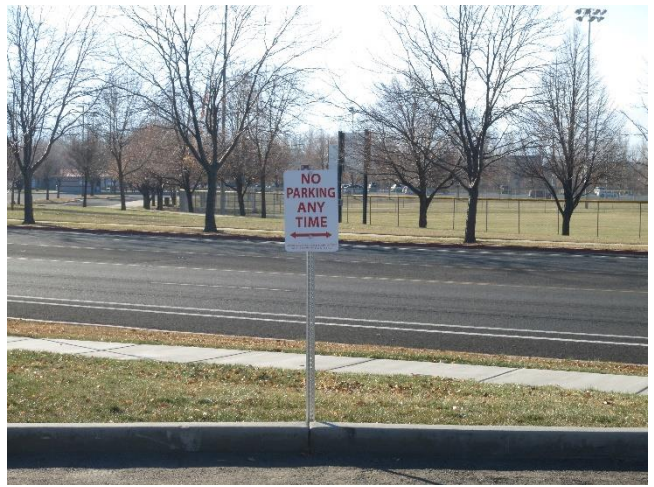
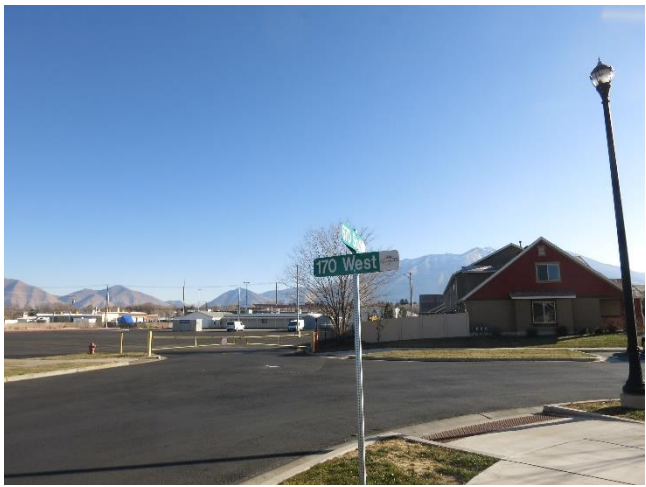
Component Name: Sign Replacement
Component Number: Common Development 3004

Sign Allowance N/A years
Beginning Year N/A

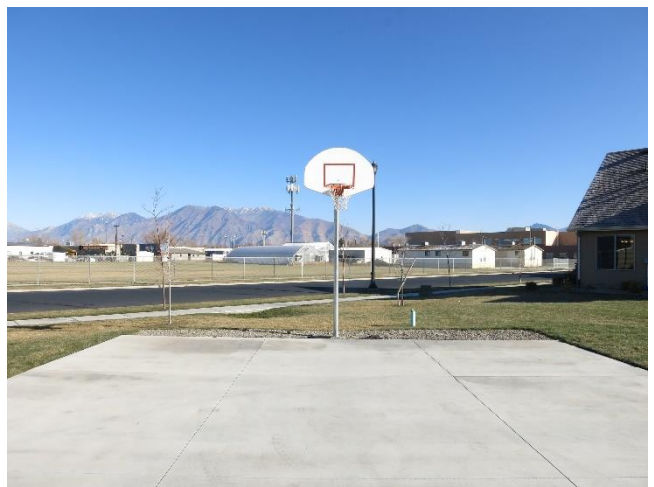
Component Name: Basketball Hoop
Component Number: Common Development 3007

Component Life Expectancy: N/A years
Average Age of Component: _____ years
Remaining Component Life: _____ years

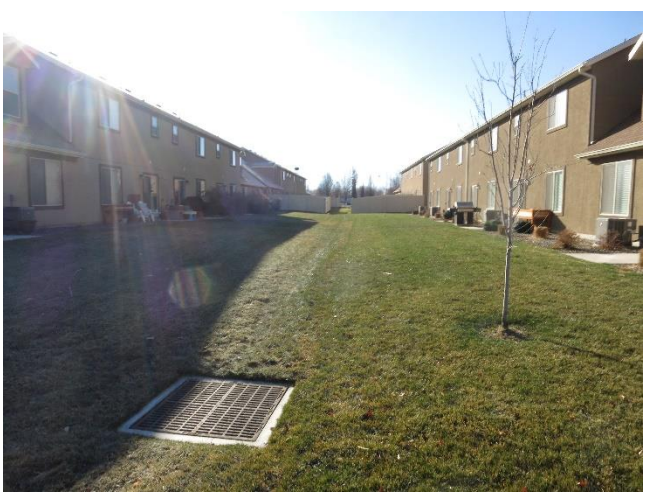
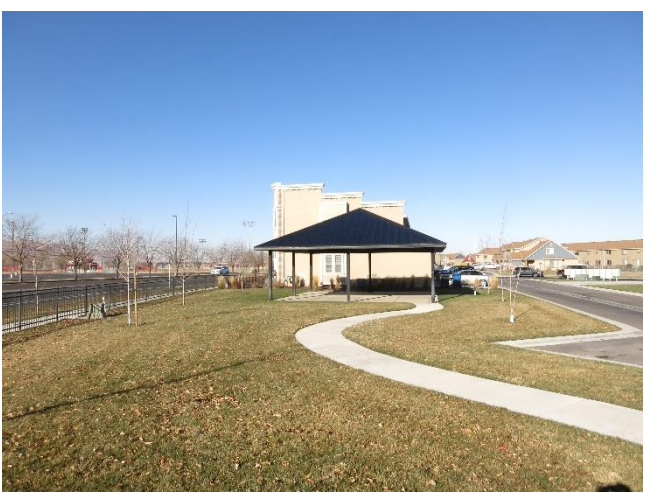
Component Name: Landscape & Irrigation
Component Number: Common Development 3010

Component Life Expectancy: N/A years
Age of Component: _____ years
Remaining Component Life: _____ years
